**WALDEN POND OUTLET DAM**

**WALDEN POND EAST END DAM**

**PHASE I INSPECTION REPORT  
NATIONAL DAM INSPECTION PROGRAM**

**AUGUST 1978**

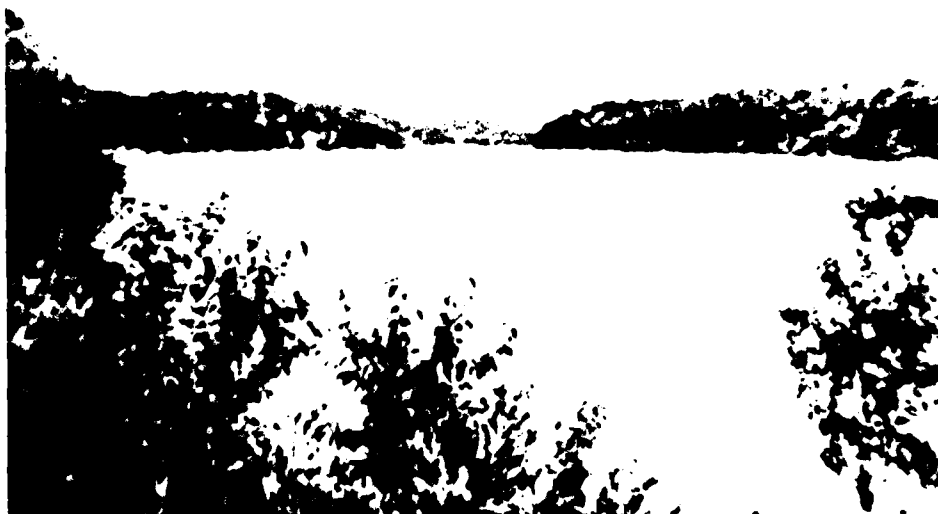
6

General View of Reservoir

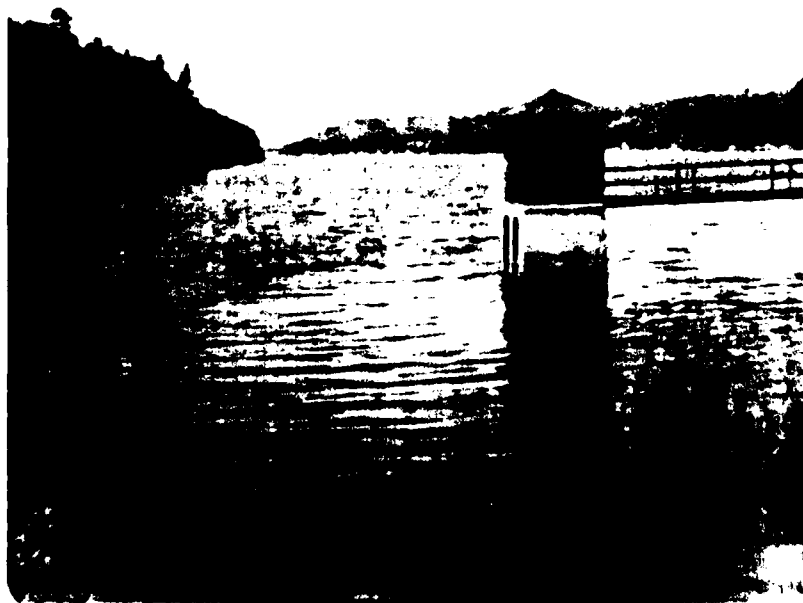
5

Looking West from Dam
